MEMORANDUM

DATE:	May 16 th , 2016
FROM:	Eric Lancaster
SUBJECT:	Weekly Progress Report @ Gold King
TO:	Steven Way

Project: Gold King Interim Water Treatment Plant (IWTP)
Location: Gladstone, Colorado
Prepared for: Emergency Response Unit – US EPA Region 8

Reporting Period: May 9 – May 16
Report No.: 21

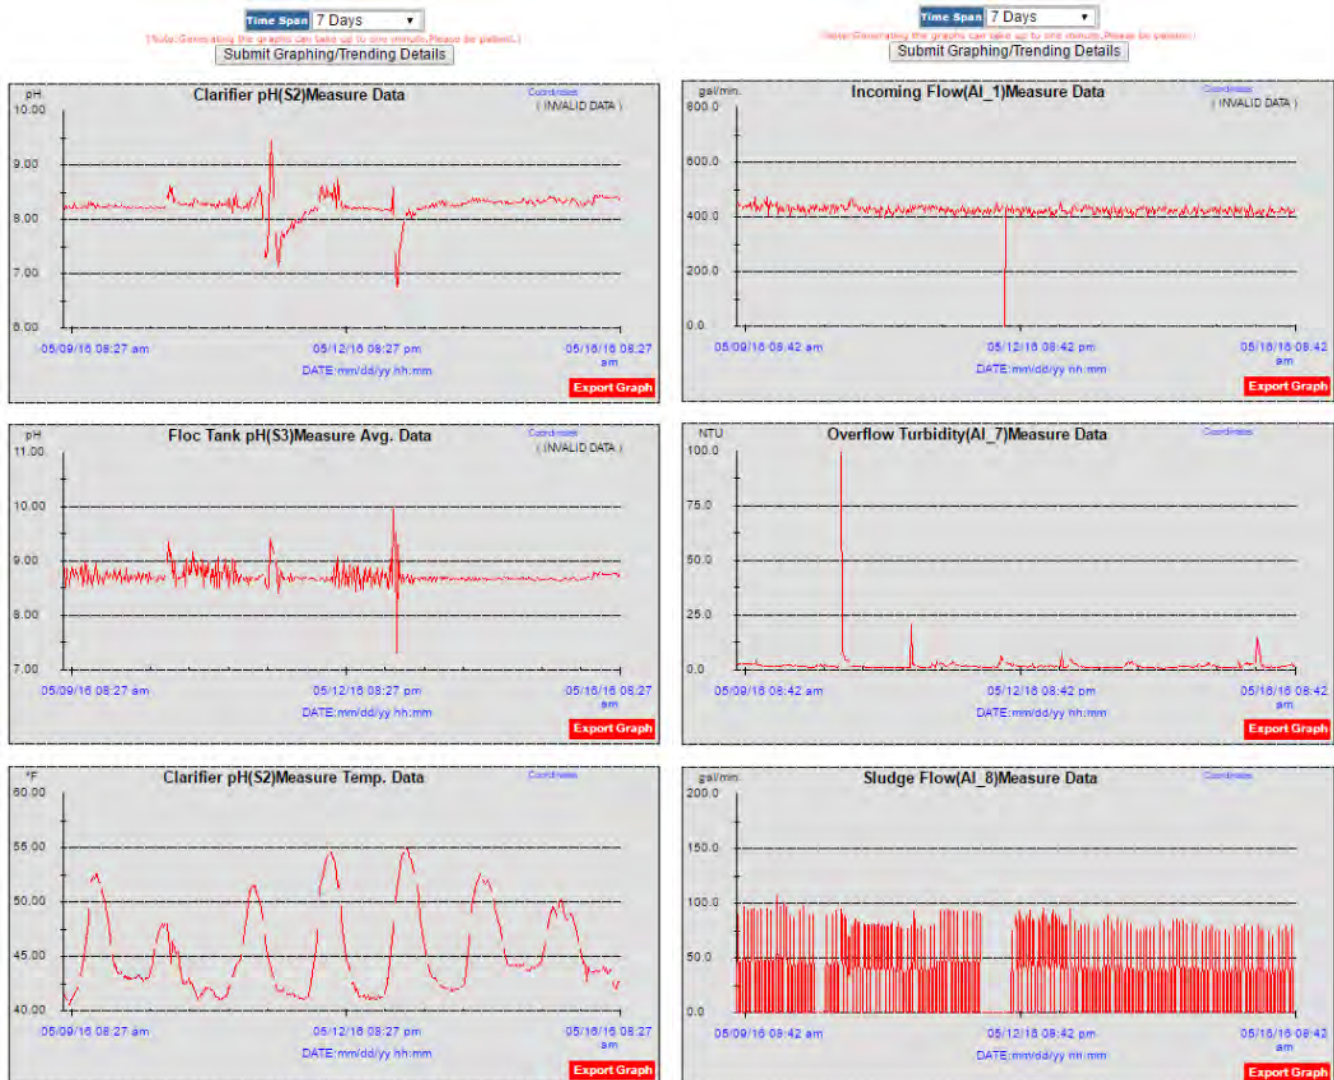
- The following graphs provide trending information during the previous 7 days. The dataloggers collect control information from the Lime Circuit (left) and Flow Circuit (right) Programmable Logic Controllers (PLCs) at the Gold King IWTP. Over the reporting period (5/9/16 – 5/16/16 inclusive) Alexco treated 4.57 million gallons at an average flow rate of 454 gpm with all discharged treated water leaving the 12" HDPE pipeline.

- Please note: Several days each week, the Alexco operators check the pH at both the flocc tank and clarifier discharge. During this time, the probe is placed in vinegar (acid), and three pH buffers – 4, 7, and 10. While the probe is in the acid/buffer, the datalogger may capture one of those points for tracking purposes, which explains the occasional pH spikes seen on the graph.
- On 5/11 and 5/13, the IWTP experienced high TSS spikes from the upper ponds, which caused some fluctuation of the pH at the clarifier as the peristaltic pumps both over and under shot lime addition.
- On 5/12, the Alexco operator briefly closed the incoming butterfly valves.
- Instantaneous spikes of the Overflow Turbidity Meter are associated with routine cleaning. However, a longer TSS spike on 5/15 is due again to a high TSS spike from the upper pond, potentially caused by storm conditions.

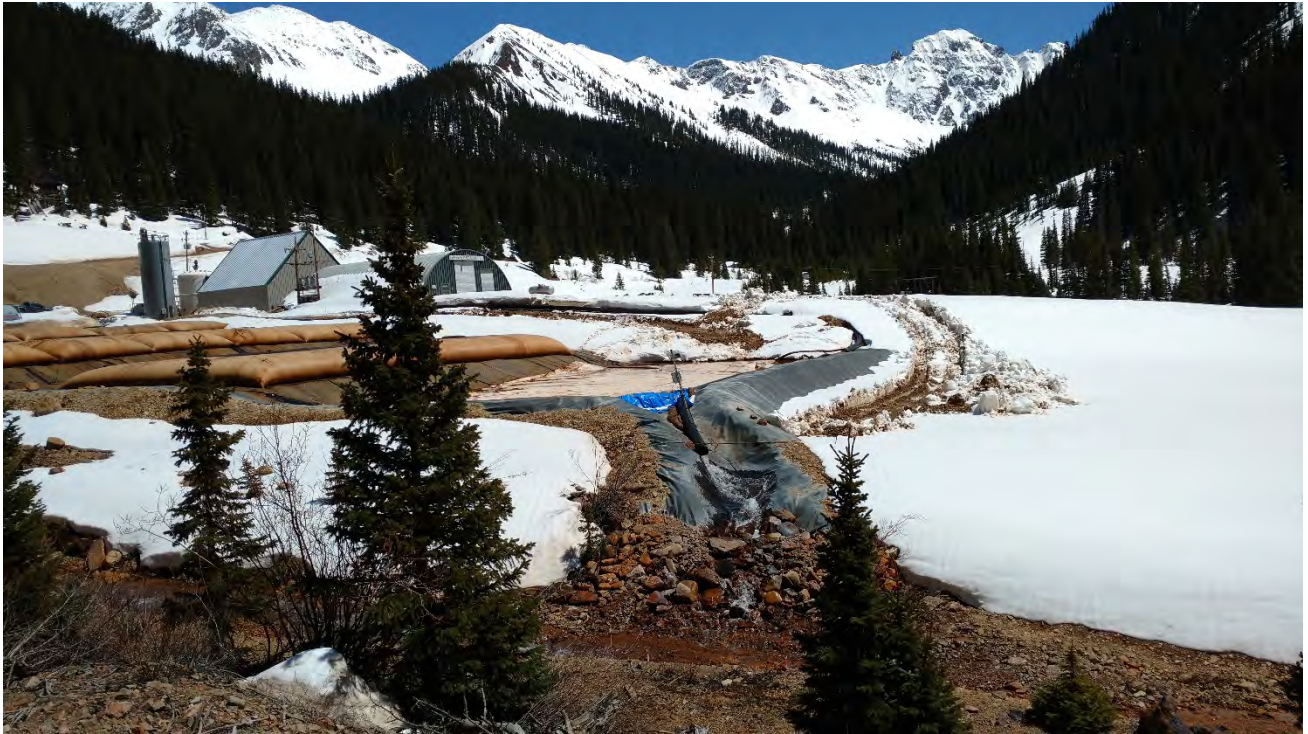
Photo 1: Site from the road near the IWTP discharge pipe – Taken on 5/12/2016

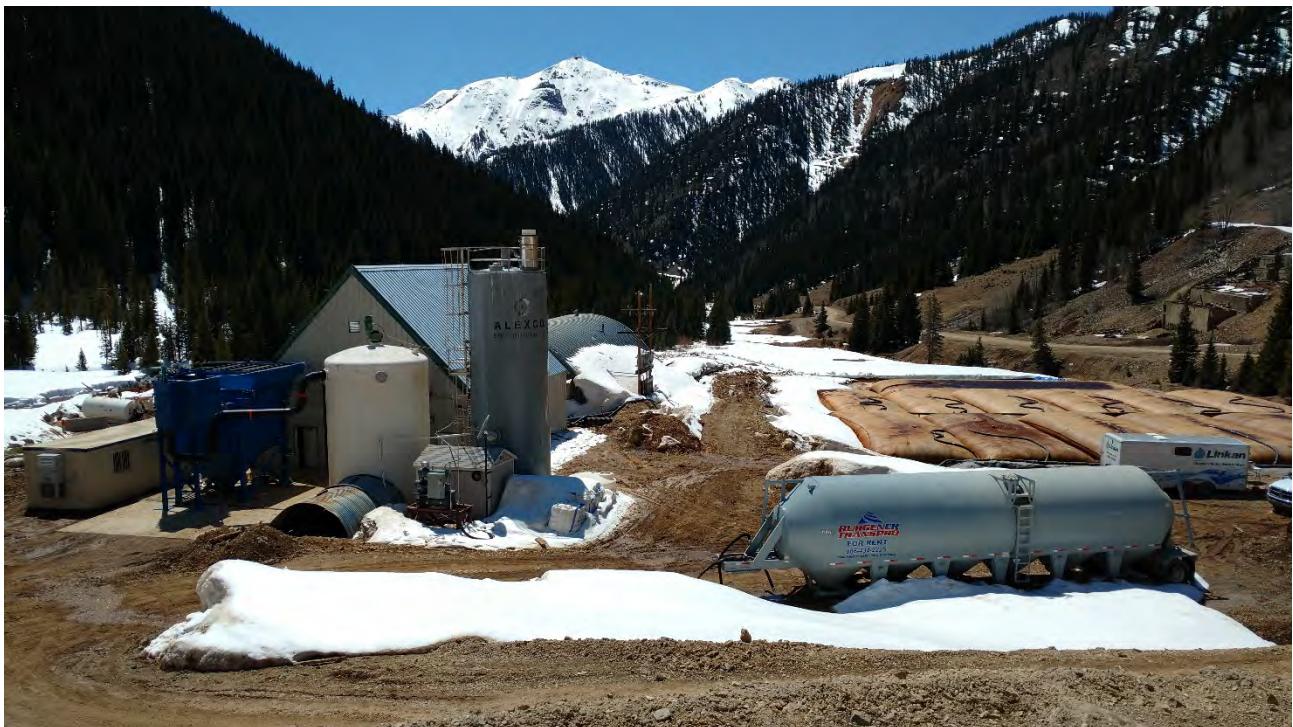
Photo 2: View of IWTP from the Upper Road – Taken on 4/12/2016

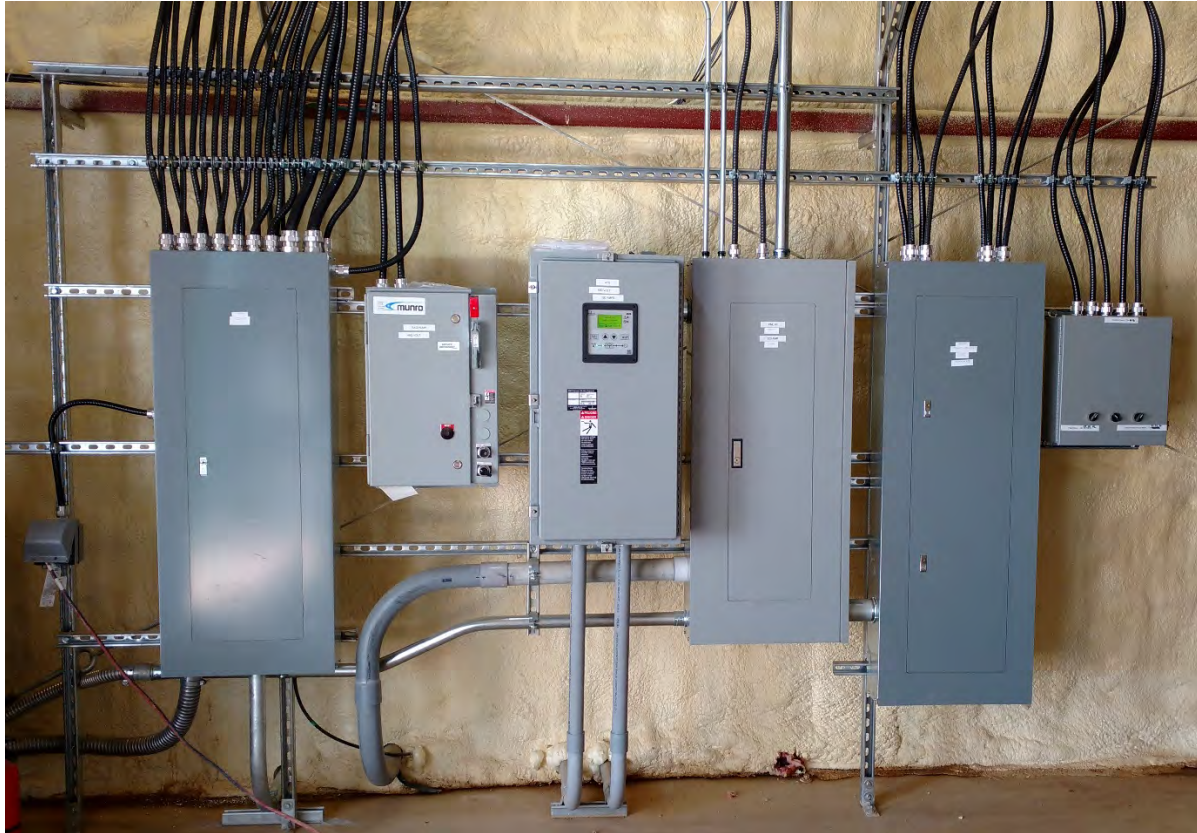
- **Electrical Upgrades** – Alexco's selected electrical contractor (Rapid Energy) began electrical upgrades on Friday, April 15th. These upgrades passed final inspection from the State Inspector on Wednesday, May 11th (see Photo 4).

Photo 3: Final installation of electrical panels – Taken on 4/12/2016

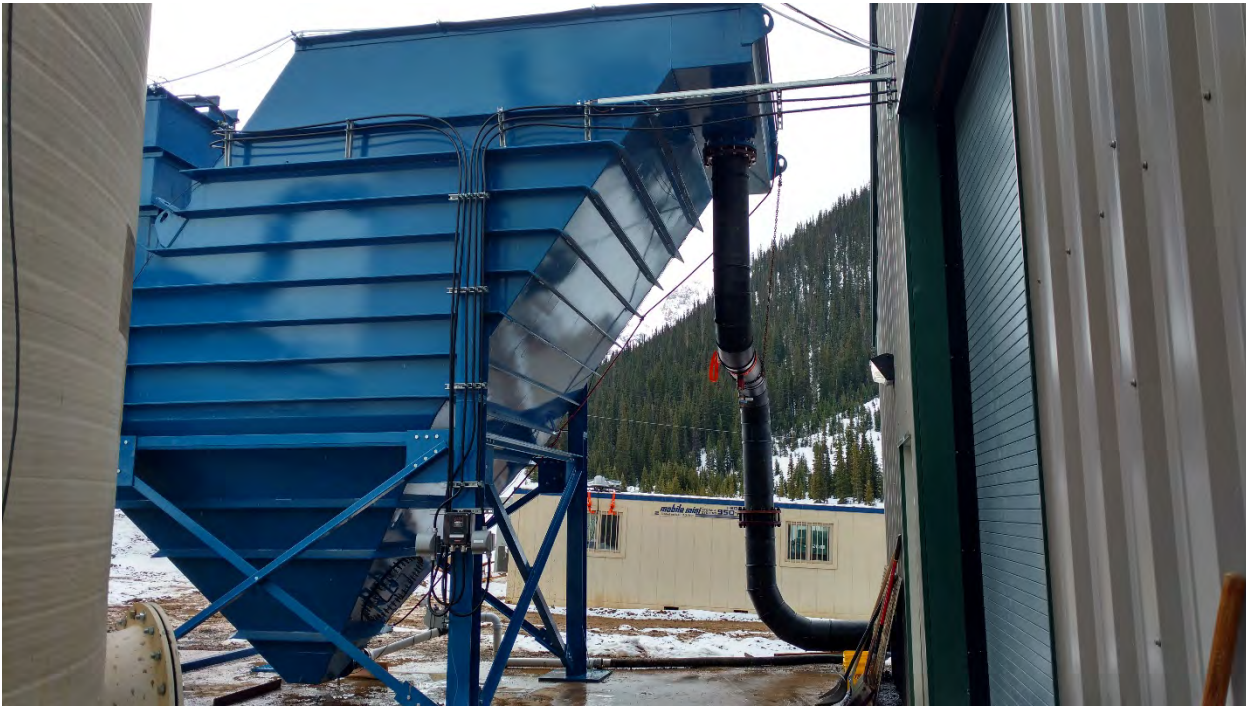
- **Second Clarifier** – Alexco has installed and operated a 2nd clarifier (rental) and supporting infrastructure that may be required for spring melt. The system was tested and became operational on Sunday, May 8th.

Photo 5: 2nd Clarifier, discharge line near IWTP – Taken on 4/10/2016

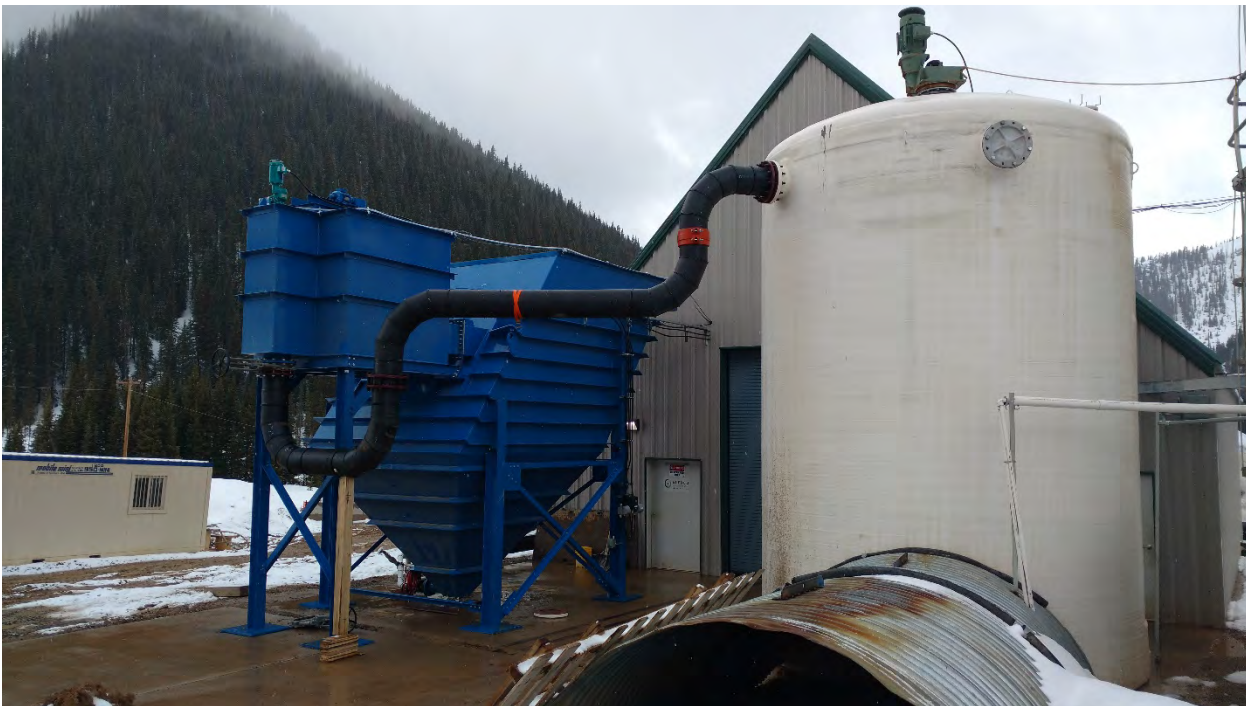
Photo 6: Incoming line from the Reactor Tank – Taken on 4/10/2016
